Technical expertise on the cause of final drive unit failure of the VAZ Niva

Ján Mandelík¹

¹(Department of Transport Safety, The University of Security Management in Kosice, Kosice, Slovak Republic)

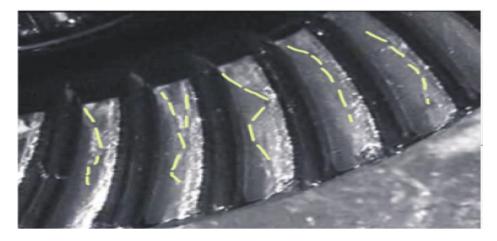
- 1. crown wheel: the displacement of all teeth of the crown wheel in and out of engaging surfaces, changed geometric shape of all teeth; changed geometric shape occurred mainly out of teeth active surfaces at their profile upper part, where an oblique imprint of counter clockwise wheel teeth was detected Fig. 6.
- 2. Pinion (pear-shaped): the displacement of all teeth of the crown wheel in and out of engaging surfaces, changed geometric shape of all teeth; changed geometric shape occurred mainly out of teeth active surfaces at their profile upper part, where an oblique imprint of counter clockwise wheel teeth was detected—Fig.7.
- 3. bevel gear shaft bearings: blue-colored surfaces, traces on the taper roller bearings.

Figure 6: Damage to the crown wheel teeth- marked

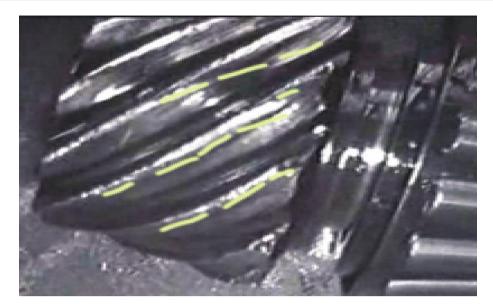
Figure 7: Damage to the pinion teeth- marked
